# BELZONA RESTORES FRESH WATER COOLERS

ID: 622

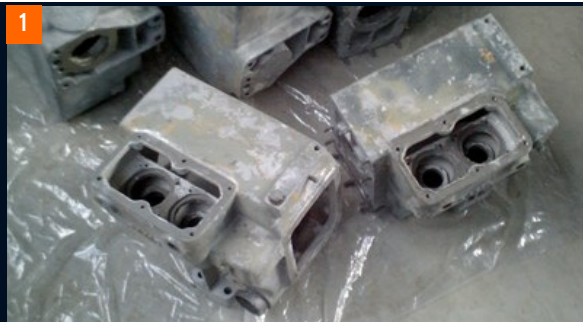
Corrosion-erosion of inside vane, outside flanges and stud threads.

1. Upper side of flange and valve seat
2. Inside vane coated with Belzona 5891
3. View of coupling flanges

Application was carried out in accordance with Belzona Know-How System Leaflets HEX-2 and HEX-3.

Belzona 5891 (HT Immersion Grade)  
Belzona 1111 (Super Metal)
