# BELZONA PROTECTS PLATE HEAT EXCHANGER COVERS

ID: 624

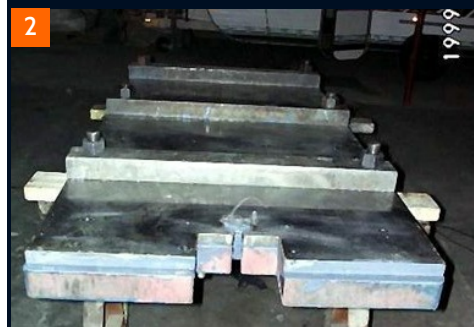
Galvanic and crevice corrosion to the end covers of the heat exchangers was resulting in leaking around the titanium plates and loss of efficiency.

1. Previously corroded cover
2. Former clamped into position
3. Post application inspection
4. Perfectly smooth finish

Using a modified version of Belzona Know-How System Leaflet GSS-9, a plate is coated with Belzona® 9411 and used to form a thick layer of Belzona 1341 on the end cover. This procedure provides a perfect finish and excellent seal.
