# BELZONA 5812DW RESTORES POTABLE WATER TANK

Internal lining and hole patching of a 100,000 gallon potable water tank

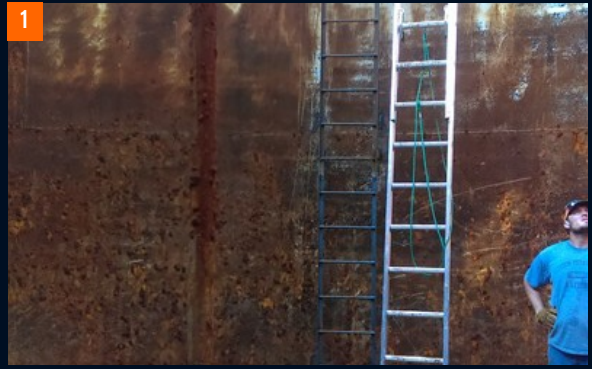
1. Wall of the tank with heavy sediment build-up, surface corrosion and pitting.
2. Surface prepared and application of Belzona 5812DW in progress.
3. Completed application to wall and ceiling with 2 coats of Belzona 5812DW.
4. Coating of the floor completes the restoration.

The sediment was removed followed by a thorough surface pressure clean. To ensure effective adhesion the surface was abrasive blasted. Holes were repaired from the outside of the tank using Belzona 1111 and Belzona 9341 in accordance with the Belzona Know-How System Leaflet TCC-1. Belzona 5812DW was applied to the ceiling, floor and inner wall of the tank according to the Belzona 5812DW Instructions for Use document.
