# BELZONA REPAIRS AT LOCAL SCHOOL

ID: 625

Erosion-corrosion on a 6,000 gallon water tank clarifier

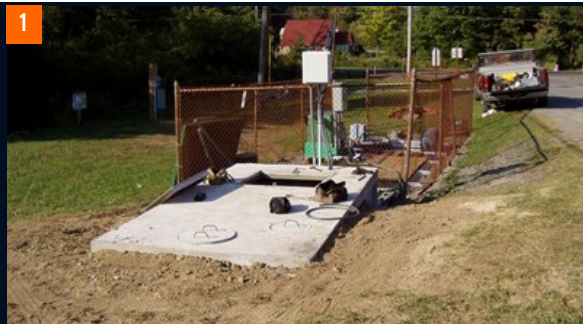
Deterioration of steel due to daily contact with chlorine.

1. Overview of the working area
2. Repairs in progress accelerating the cure time
3. Completed repairs

Welding in this instance would have been costly and time consuming due to the limited space and working in over 6 feet of water, Belzona® 1111 was therefore used. The Belzona solution was completed in two hours as compared to a whole day with a traditional repair approach and the school stayed open during this entire time.
