# BELZONA REPAIRS SWIMMING POOL

ID: 6253

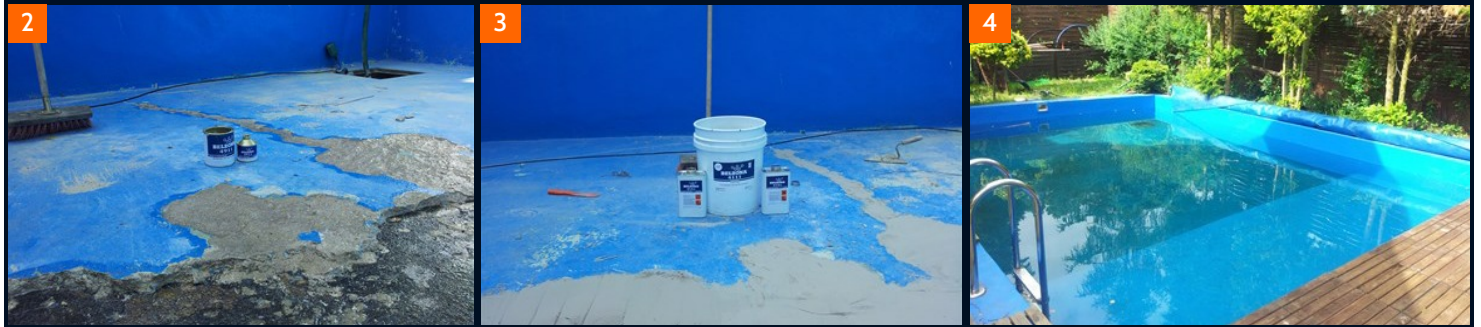
A significant water leak from the pool due to the crack of the concrete.

Concrete crack on the bottom of the swimming pool .

1. General view of the damaged bases
2. The bottom of the pool after the application of Belzona 4151
3. Supplementing concrete damage - Belzona 4111.
- 4.General view of the swimming pool.

Previous repairs to other materials did not cause inhibition of the leak. Removed loose and wet concrete parts. The entire exposed concrete was painted Belzona4151. At the end of applied Belzona 4111.
