# BELZONA CURES DRUG FACTORY FLOOR

ID: 6255

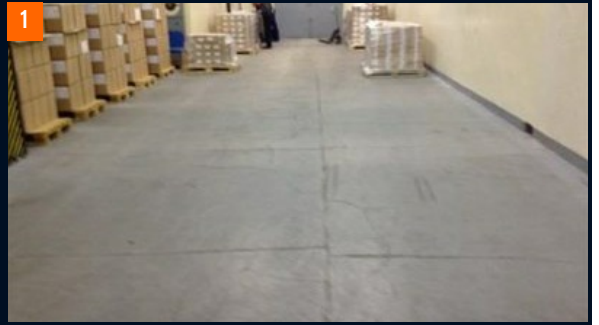
Very damaged and cracked concrete floor in the medicines factory.

1. View of damaged warehouse floor 2.  
Close up of the cracked concrete 3.  
and 4. The floor after application of Belzona 5811

Application was carried out in accordance with Belzona System Leaflets FPA-1 and FPA-3.

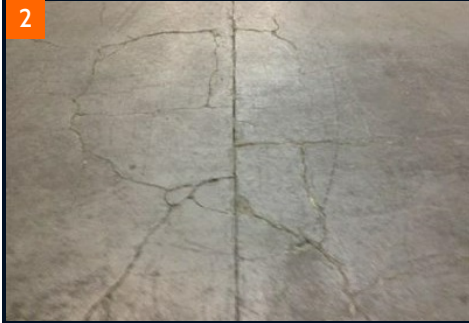
The cracks collect a lot of bacteria and contaminants creating a serious hygiene issue.

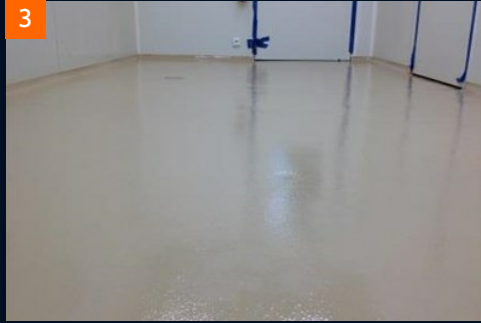
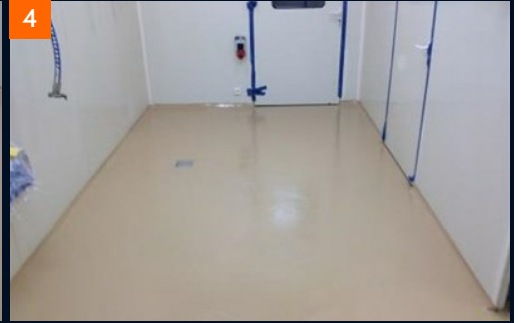
Solvent free Belzona system enabled floor repairs to be carried out with minimal disruption to production in adjoining areas. Belzona repair provided a smooth, easy clean, hygienic surface suitable for pharmaceutical production.
