# BELZONA LEVELS TAXI STAND

ID: 6256

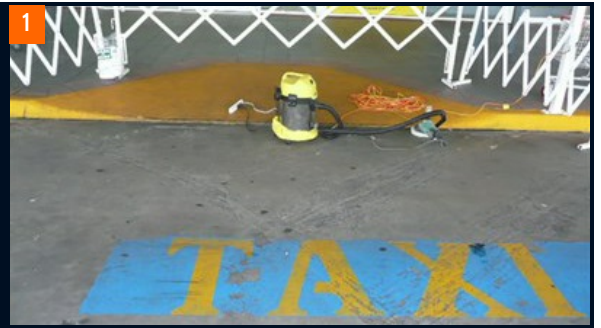
The concrete slab, adjacent to the ramp for the taxi stand, had sunk and created a step that had become a trip hazard. This had also made wheelchair access difficult.

1. The taxi stand ramp
2. Close up showing the step between the ramp and road with surface preparation underway
3. The finished application
4. Three years on and still in perfect condition

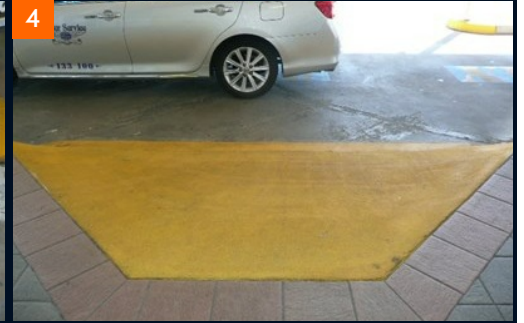
Belzona 4000 series materials are the product of choice for this busy shopping centre because they allow repairs to be carried out quickly and easily with minimum disruption and at the same time provide long term, permanent repairs. Even after 3 years of constant use, the ramp is still performing well with no signs of deterioration or cracking
