# PUMP REPAIR AND EFFICIENCY ENHANCEMENT WITH BELZONA

ID: 626

Large horizontal split case pump housing

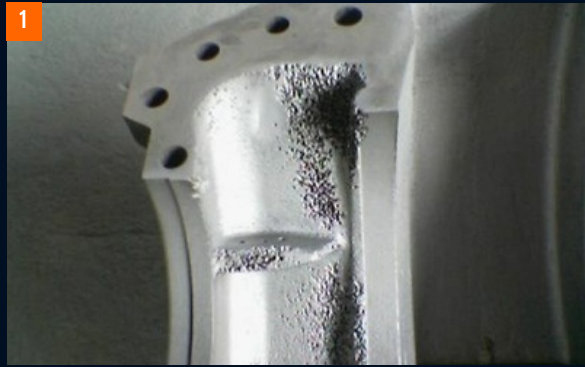
The pump had significant corrosion.

1. The severe localised corrosion
2. Application of Belzona 1111
3. The completed repair
