# BELZONA REPAIRS COAL STORAGE BIN

ID: 6268

Damaged concrete lip on a 10 metre diameter coal storage tank

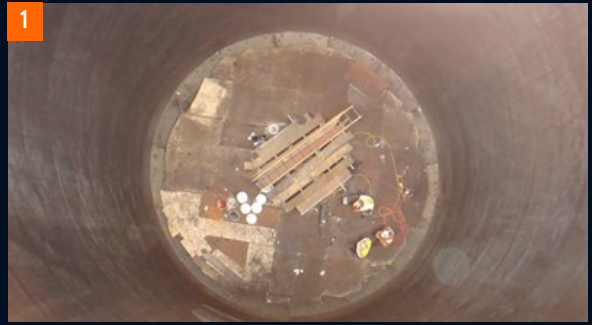
Constant abrasion had caused severe wear to the transition lip on the concrete coal chute. The abrasion was so severe that the reinforcement bars had been exposed and in some cases were also worn through.

1. View from the top of the bunker showing the extent of the repairs to be done 2. Conditioning the substrate and re-bars 3. Repairs in progress 4. Repairs complete
