# END SUCTION PUMP REPAIRS WITH BELZONA

ID: 627

Several large end suction pumps used in processing of sugar beet.

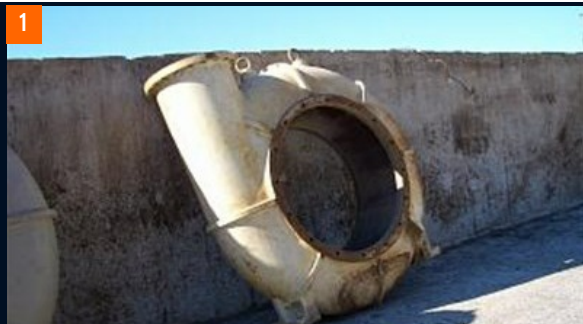
The pumps had suffered severe erosion and significant corrosion caused by solids entrainment.

1. Pump housing
2. End covers with erosion clearly evident
3. The components restored to original dimensions

Application was carried out in accordance with Belzona Know-How System Leaflet SHM-11.
