# BELZONA ROOF REPAIRS AT PROMINENT RETAILER

ID: 6271

Roof leaks on a Department store roof.

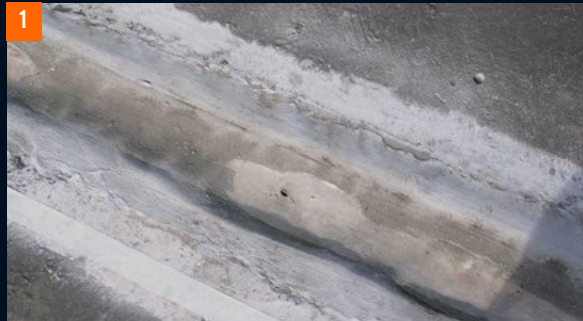
Leaking joints were causing disruption to staff and shoppers at this high end department store.

1. The leaking joints 2. Masking off before starting application 3. Conditioned joints 4. Application of Belzona 3111 in progress
