# BELZONA SEALS PARAPET WALL

ID: 6276

Parapet wall on the roof of a Shopping Centre

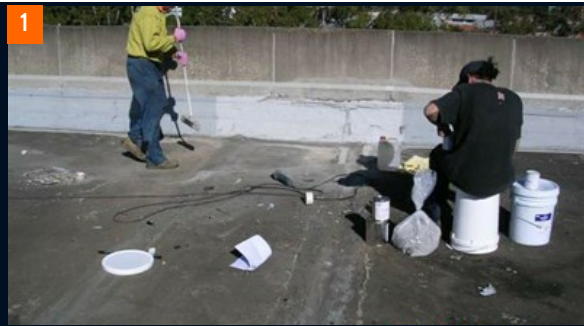
Ingress of water into the building below caused by failed sealant on the parapet wall joints.

1. Preparation in progress 2. Surface Conditioner applied 3. completed application

Application was carried out in accordance with Belzona System Leaflet RPA-8. A fully reinforced Belzona 3111 system was applied to bridge between roof deck and wall.
