# BELZONA RENEWS EXPANSION JOINT AT SHOPPING CENTRE

ID: 6277

Failed Expansion joint at a Shopping Centre.

Shopping Centre, NSW, Australia

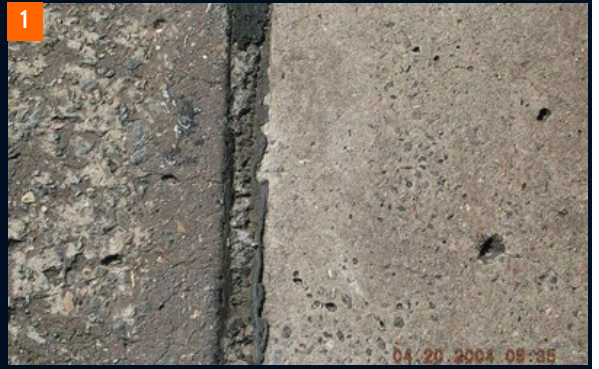
The existing joint material had failed resulting in a route for water to leak to the building below and was also creating a trip hazard.

1. The failed joint
2. Rebuilding with Belzona 4111
3. Packing the joint with backer rod
4. Pouring the Belzona 2221 Elastomer to finish the job
