# A NEW BELZONA EXPANSION JOINT FOR NEWSROOM

ID: 6278

Expansion joint in a newsprint production floor.

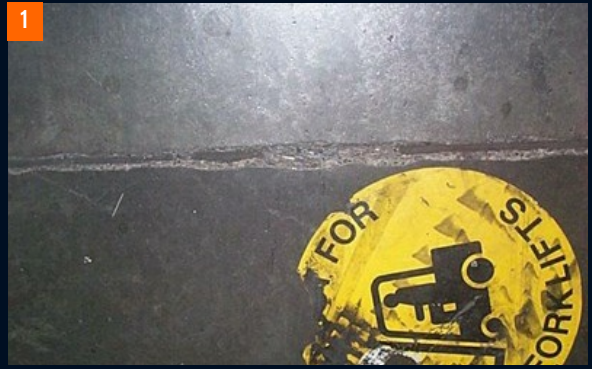
The existing joint and adjoining concrete slab had been damaged by constant fork truck traffic. This was now becoming a Health & Safety issue.

1. The existing joint with warning signs attached
2. Joint masked off and Conditioner being applied
3. The Belzona 2221 being poured
4. The newsprint production equipment

The application was carried out in accordance with Belzona System Leaflets FPA-5 and FPA-6. The existing joint material was removed and the concrete slab edges rebuilt back to square using the Belzona 4111 before pouring the Belzona 2221 system to seal the joint.
