# BELZONA SAFETY FLOORING AROUND MIXER

ID: 6279

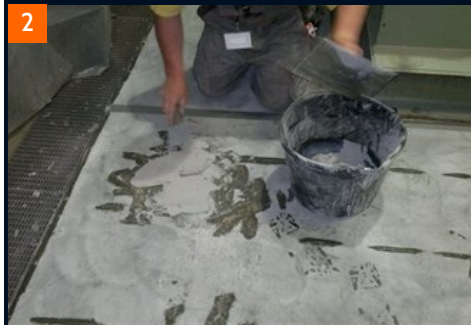
1. Grinding concrete floor
2. Repair of damage and filling cavities with Belzona 4111
3. Application of Belzona 4411
4. General view of the floor after application of Belzona 4411 system

The application was carried out in accordance with Belzona System Leaflet FPA-8. After removing rubber sheets and cleaning the concrete, Belzona 4111 was used to level the concrete before applying the Belzona 4411 non-slip system.
