# BELZONA RESTORES CORRODED PUMP HOUSING

Horizontal split case centrifugal water distribution pump.

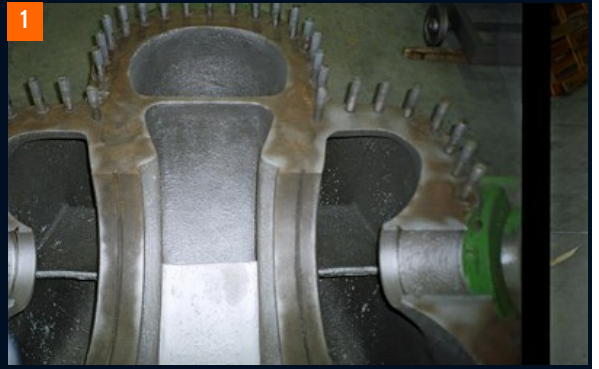
The pump had extensive corrosion.

1. Corroded pump housing
2. Corroded pump outlet
3. Application of Belzona 1341
4. Completed application
