# BELZONA REFURBISHED LOADING DOCK STILL GOOD 7 YEARS ON

ID: 6281

Loading dock and car park of a multi use business complex.

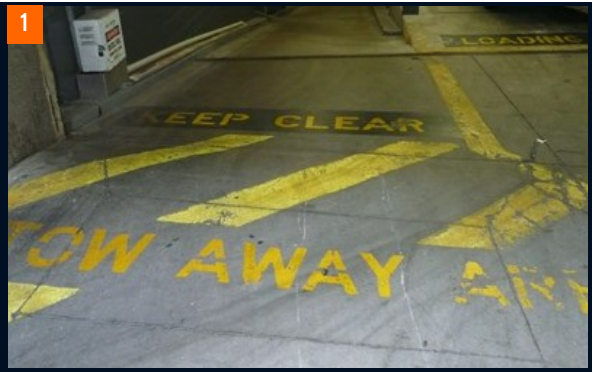
The Loading dock and car park were old and in need of a facelift as all of the original coating had been worn away.

1. The original condition of the floor area
2. Surface preparation in progress
3. The finished application showing the coated floor and reinstated lines, wording and chevrons
4. The floor after 7 years in service

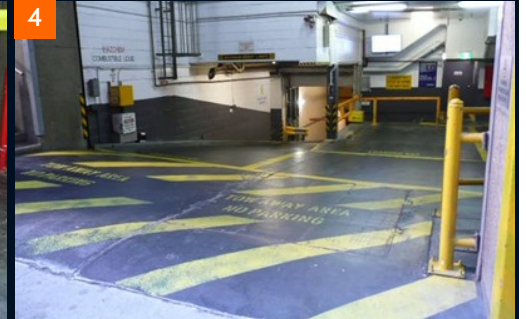
Belzona materials were chosen due to their ease of application, proven longevity and incorporated grip system that provides a safer and more durable finish than conventional floor paints. This decision has proven to be the right one as the floor is still in a serviceable condition 7 years later
