# BELZONA REPAIRS AND RESURFACES CRACKS IN CONCRETE SWIMMING POOL TANK

ID: 6284

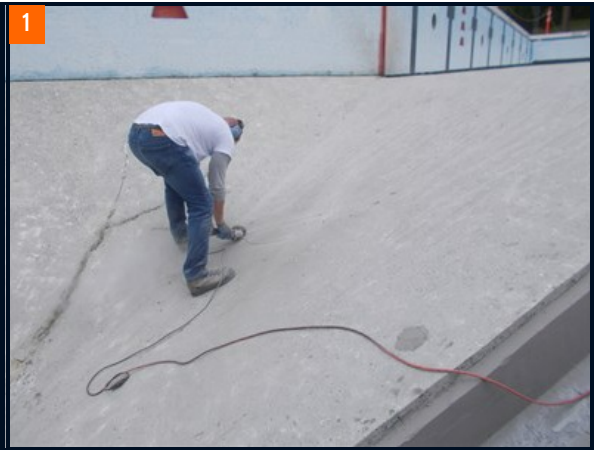
1. Preparing cracks with a 1/4 inch diamond blade to depth of 1/2 inch.

The application was carried out in accordance with Belzona Know-How System Leaflet FPA-1. The surface was prepared by using a 1/4 inch diamond blade. Belzona 4911 was applied and then Belzona 4111 was applied directly on to the conditioned surface with a float.

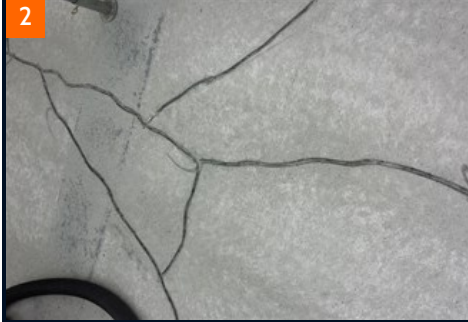
2. General view of various prepared cracks

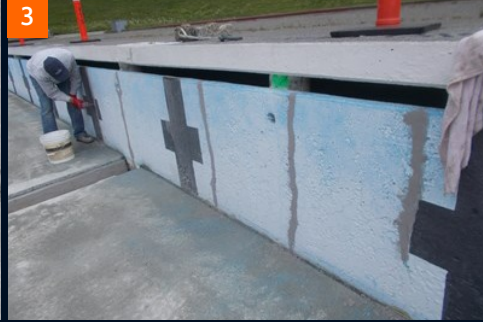
3. Cracks in the pool walls repaired in a similar fashion.

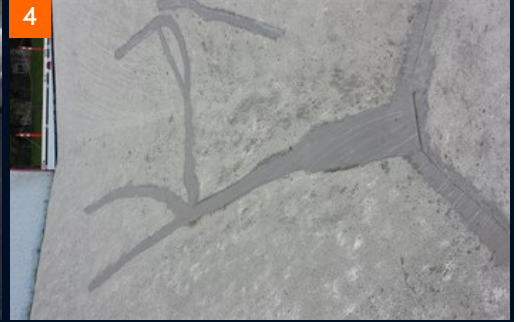
4. Completed repairs in the diving tank. A total of more than 600 feet of cracks were rebuilt and resurfaced in this manner.
