# BELZONA RESURFACES WATER SUPPLY TROUGH AT OUTDOOR SWIMMING POOL

ID: 6287

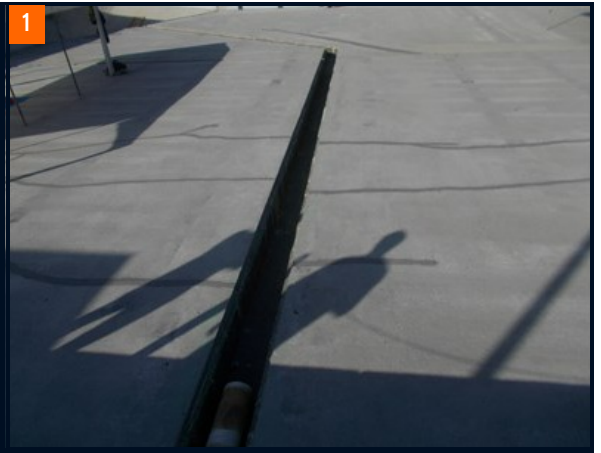
1. View of water supply channel
2. View of the eroded surface that need to be resurfaced
3. Resurfacing with Belzona 4111 in progress.
4. Completed supply channel

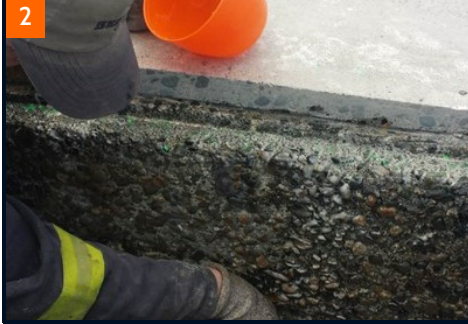
Over period of many years, the pool chemicals had attacked the concrete channel leaving the aggregate exposed. Ultimately loose aggregate would get into the pumps and damage them.
