# BELZONA SEALS LEAK IN UNDERWATER OBSERVATION WINDOW

ID: 6289

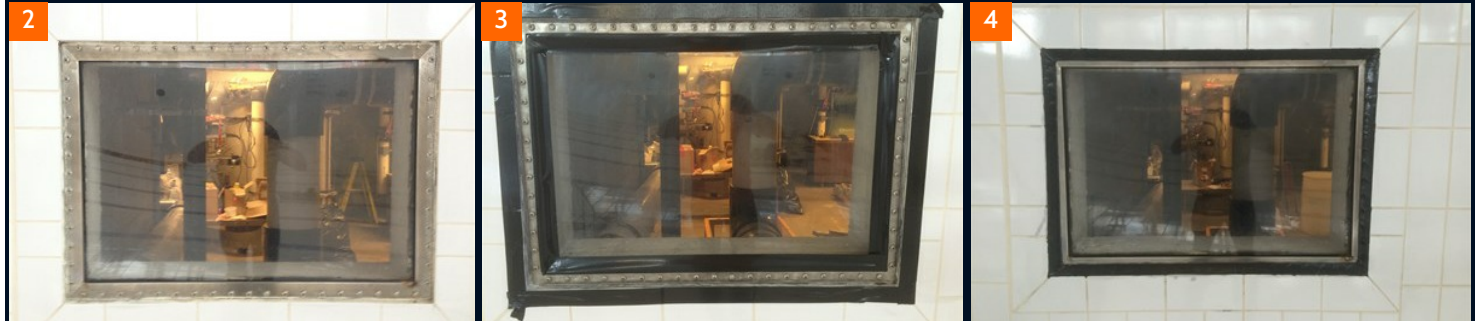
## PHOTOS

The underwater observation window had developed a leak.

1. View of observation window
2. Metal surface prepared
3. Perimeter of the window masked off
4. Completed application with all tapes removed

The application was carried out in accordance with a modified Belzona Know-How System Leaflet FPA-6. The stainless steel surround was prepared using a grinder to achieve a clean rough profile on the metal surface. After masking off the perimeter, a  $\frac{1}{8}$  thick rubber tape was used to create a suitable clearance on the inside of the window-sufficient to clear the screw heads.
