# PROTECTING ENGINE BLOCK WITH BELZONA

ID: 629

Engine block from tug boat

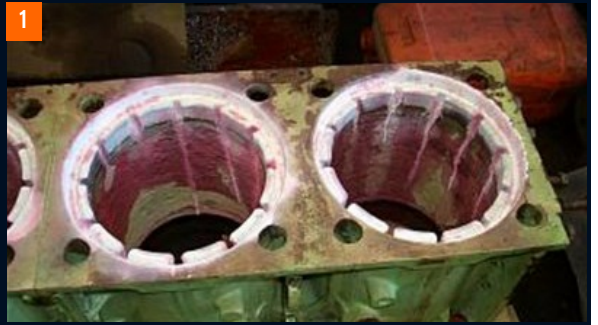
Corrosion in water jacket around cylinder liners.

1. Corroded block with liners removed
2. Surface preparation by grit blasting
3. Application of Belzona
4. Finished application
