# BELZONA SEALS HIGH 270° CIRCULAR PARAPET WALL

ID: 6290

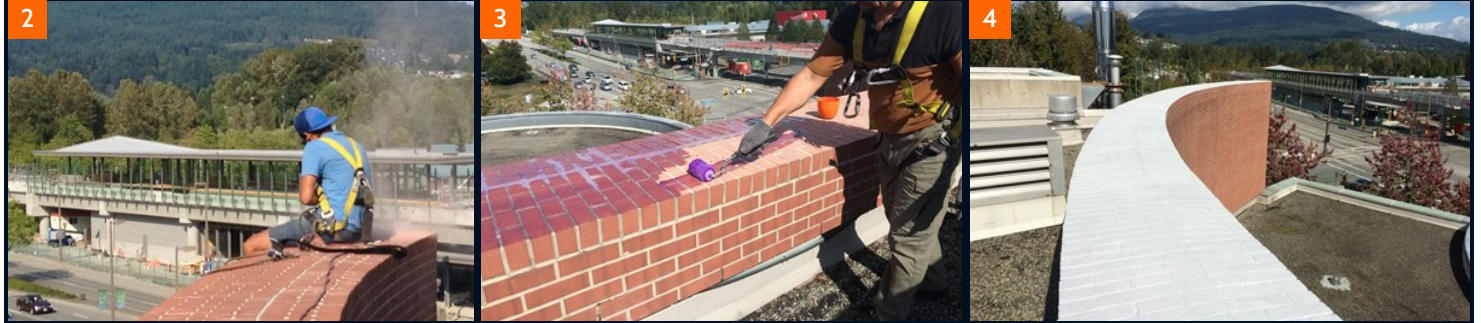
1.View of wall being pressure washed prior to application. It was established at this point that the bricks may have been sealed at some points creating a possible adhesion problem.

2.The brick surface being ground to ensure adequate adhesion

3.Application of Belzona 3911

4. Application of 1st coat of Belzona 3111 completed.

The application was carried out in accordance with Belzona Know-How System Leaflet RPA-1. All contamination was removed

Belzona 3111 has good record of been able to protect parapet type walls where movement is a constant problem. Belzona 3911 was applied. Lay out Belzona 9311 over the conditioned area to be treated. Belzona 3111 was applied over the Belzona 9311.
