# BELZONA REPLACES INDOOR SWIMMING POOL EXPANSION JOINTS

ID: 6292

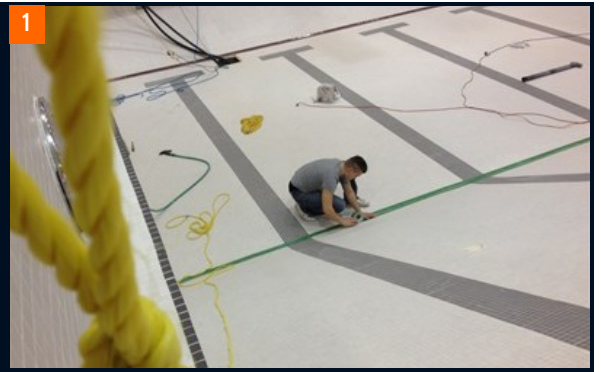
1. Joint preparation completed by grinding the expansion joint slot to a clean dry porous finish
2. Joint masked off to ensure a neat and tidy finish
3. Application of Belzona 2221
4. Completed application.

The application was carried out in accordance with Belzona Know-How System Leaflet FPA-6. The surface was grinded to a clean dry porous finish, then Belzona 2221 was injected into the joint and allowed to settle and cure.
