# BELZONA REPAIRED CAR PARK JOINT STILL INTACT

ID: 6294

The floor joint between concrete slabs in a Car Park

Shopping Centre, Brisbane, Australia

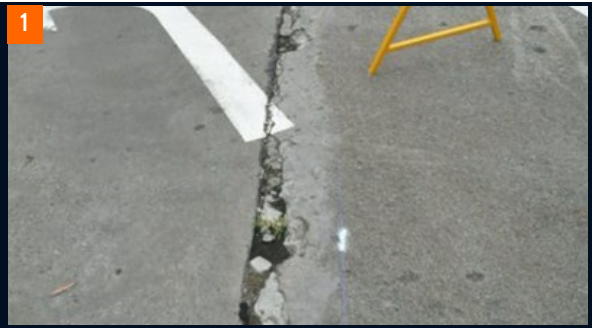
The edge nosings of the concrete slabs had been broken down to rubble after years of daily traffic making them unsightly and dangerous

1. The damaged floor joint
2. Conditioned and ready for repair
3. Repairs in progress
4. Repaired joint 3 years after completion

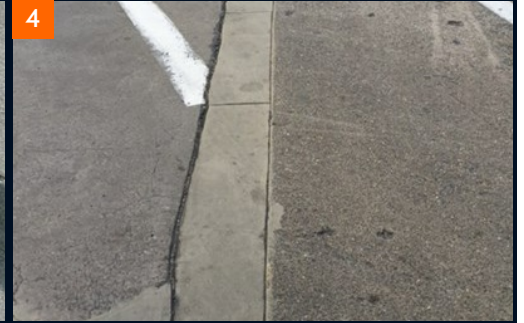
Belzona 4111 was used for its high strength, fast curing and ease of application. The floor repair is still in good condition more than 3 years later.
