# BELZONA PROTECTS ACID BUND AT CHEMICAL PLANT

ID: 6295

Tanker loading/unloading station for 98% Sulphuric Acid.

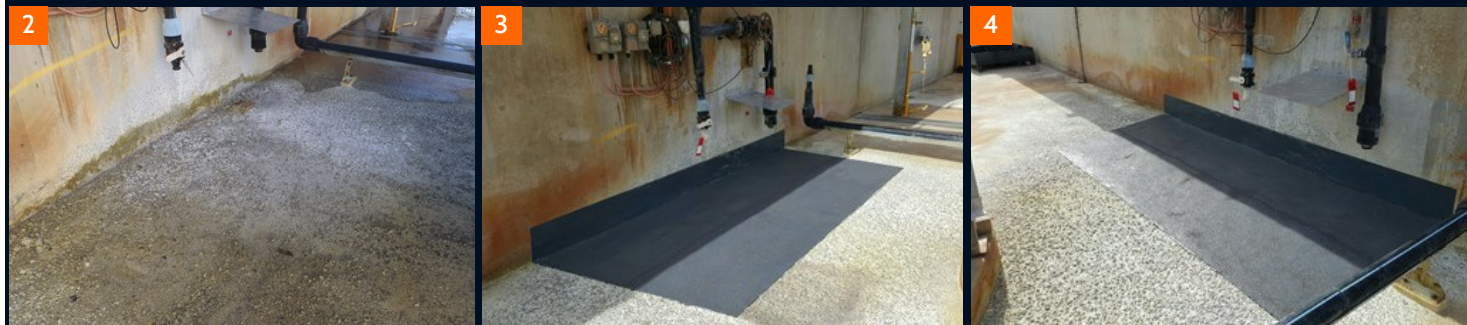
The concrete floor of the bund had been damaged by leaks during tanker deliveries.

1. Original condition of concrete before repair
2. Another view of the damage
3. Completed application
4. Another view of the completed application

Application was carried out in accordance with Belzona System Leaflet TCC-15. The floor of the bund was first washed to neutralise any remaining acid contamination before being abrasive blasted. Belzona 4111 used to rebuild damaged concrete before applying two coat system of Belzona 4311. Aggregate was applied to top surface whilst wet to create a non-slip surface.
