# 80 TONNE BULLDOZER TRACKS-NO PROBLEM FOR BELZONA

ID: 6296

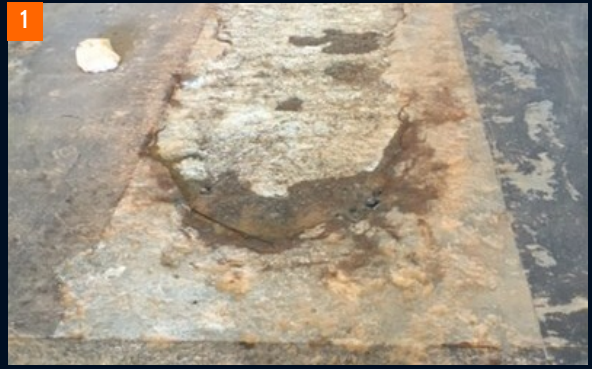
The workshop floor had been damaged by the caterpillar tracks making 180 degree turns tearing up the concrete.

1. The damaged concrete floor 2. Another area of damage 3. Close up of the repaired area 4. View of the workshop showing repairs

Application was carried out in accordance with Belzona System Leaflet FPA-1. The floor area was badly damaged and had to be dug out to provide a suitable surface for rebuilding. Once done the area was rebuilt to the original level using the Belzona 4111 system.
