# BELZONA REPLACES EXPANSION JOINTS IN OLYMPIC SIZED LAP POOL

ID: 6299

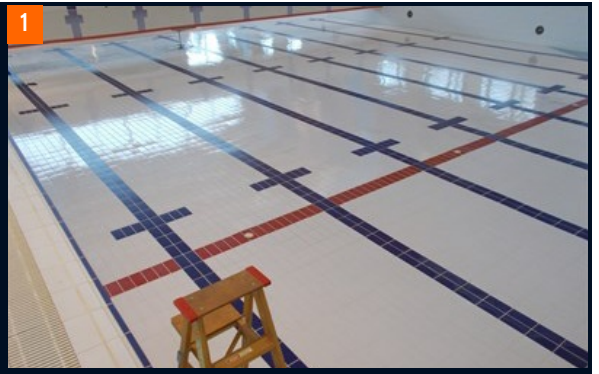
1. Overall view of the size of the facility
2. Old flexible jointing material being removed.
3. Application of Belzona 2211/2221
4. Completed application after masking tape has been removed.

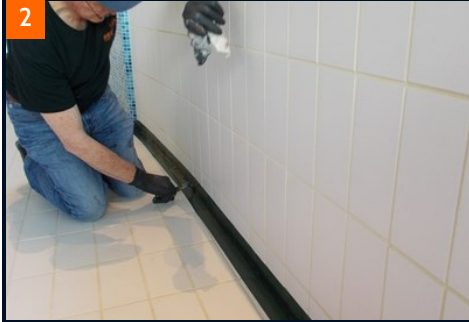
The expansion joints of a pool suffering from chemical attack.

The application was carried out in accordance with a modified version of Belzona Know-How System Leaflet HEX-13b. The old jointing material was completely removed prior to application. Concrete substrate was roughed and cleaned and then Belzona 2211 and 2221 were injected into the joint before being troweled into place.
