# BELZONA 1212 KEEPS RO WATER FLOWING

ID: 6304

Pumping system in Reverse Osmosis (RO) water plant at a 2X300 MW Coal based power plant.

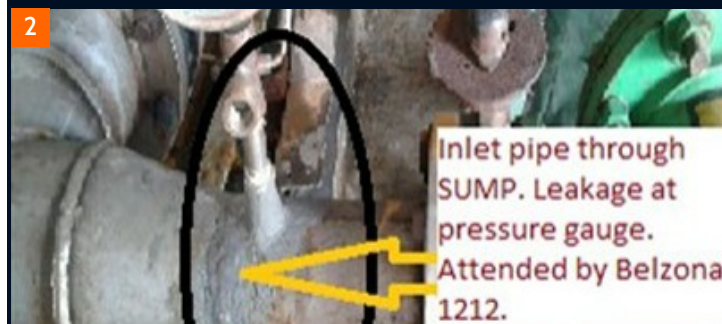
Water leakage at 5-6 kg/cm<sup>2</sup> at 7 numbers of circumferential joints from inlet pipe of SAM turbo pump.

1. SAM Turbo Pump before repair 2. Wetting the surface with Belzona 1212 3. Finished repair

Application was carried out in accordance with Belzona System Leaflet VPF-11. Leakages located on-line under operation. Surface preparation with hand grinder to prepare the substrate. Belzona 1212 incorporating two wraps of Belzona 9341 applied with system offline. System allowed to cure for 3 hrs at 30°C before bringing system back online.
