# TANK ROOF REPAIR

ID: 631

Drinking water supply tank

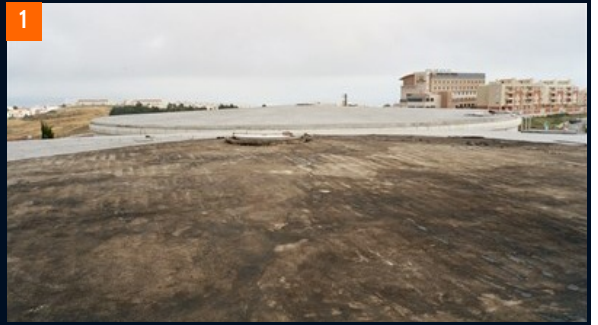
The roof was badly deteriorated. Concrete cracked due to the very hot and dry environment, as well as strong UV attack and potable water was being contaminated.

1. Damaged tank roof in 2004 2.  
Preparation of roof surface in 2004 3.  
Application of Belzona in 2004 4. The  
application is still in good condition in  
2011

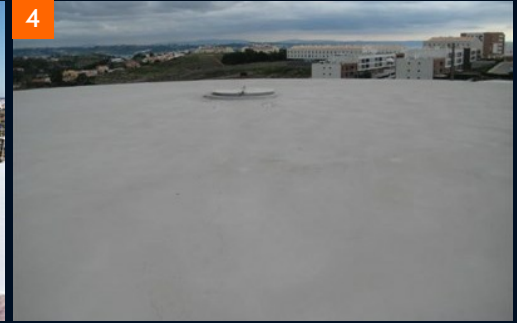
The client was impressed by the performance of Belzona on other applications in the region. The products excellent UV resistance, weatherproofing properties and long lasting life meant that this was an economical long term repair. In 2011, the application was inspected and found in good condition. Customer is very satisfied with this solution.
