# BELZONA RESEATS RUDDER TO A RUDDER STOCK

ID: 6319

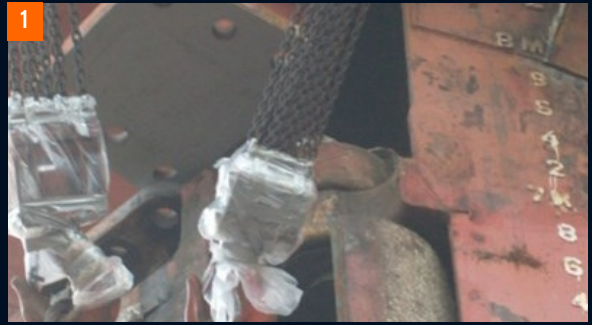
Corrosion had developed between the two mating surfaces that made it impossible to effectively seal against sea water penetration. The alternate method of repair would be machining both surfaces which would have been impossible under these dry docking conditions.

1. The corroded surface of the rudder after grit blasting.
2. The repair area coated with Belzona 1321.
3. The completed application.

The application was carried out in accordance with a modified version of Belzona Know-How System Leaflet SOS-8. The corroded surface of the rudder was grit blasted to a near white metal finish. While the other surface was cleaned and coated with Belzona 9411. The grit blasted surface was given a full coat of Belzona 1321 and allowed to firm up for approximately 2 hours before it was bolted into position.
