# BELZONA PROVIDES FOOD FOR THOUGHT

ID: 632

Large exhaust duct bend

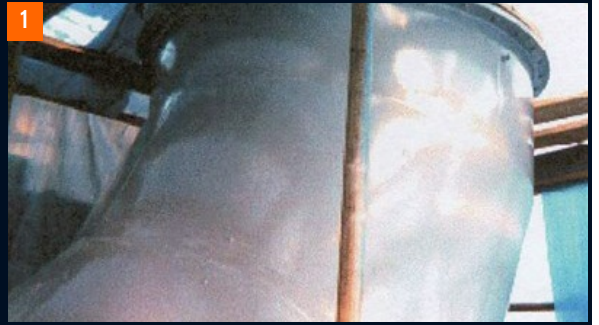
Several holes in the weld seams and isolated pinholes. All surfaces showed signs of corrosion and existing paint work was cracked and peeling.

1. Exhaust duct outlet
2. Exhaust duct bend
3. Exhaust duct repaired

Application was carried out in accordance with Belzona Know-How System Leaflets VPF-1 and VPF-2.
