# BELZONA DELIVERS ACCURACY TO A WEIGH SCALE PLATFORM

ID: 6320

The mating surfaces between sections of a weigh scale platform.

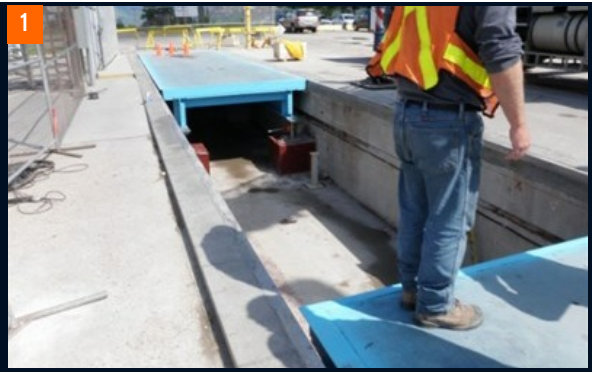
The scale consists of three separate sections bolted together; the machined surfaces where the sections connect were corroded and could no longer provide the solid connection required for accuracy.

1. The mating surfaces between sections of the weigh scale platform were badly pitted.
2. The center section of the scale had to be lowered into this gap with only 1/4 inches of clearance either end.
3. The center section was in place and bolted to the ends with Belzona 1121.

The application was carried out in accordance with a modified version of Belzona Know-How System Leaflet GSS-4. The mating surfaces between sections of the weigh scale platform were badly pitted. They were originally coated with a blue paint, which was removed prior to application. The center section of the scale had to be lowered into this gap with only 1/4" of clearance on either end. The center section was in place and bolted to the ends with Belzona 1121 providing a positive contact between the mating surfaces to ensure accuracy.

The corroded surfaces were prepared, then Belzona 1121 was applied between the connectors, prior to bolting to fill any voids caused by corrosion and provided full contact irregular shim between the surfaces. The extended set up time of Belzona 1121 allowed the delicate assembly to proceed without haste.
