# BELZONA REBUILDS A DAMAGED BEARING HOUSING

ID: 6321

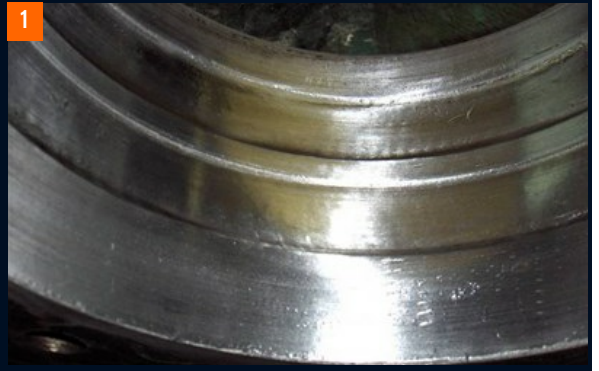
Bearing had seized due to the lack of lubrication. This caused it to spin loose and erode away the metal on the bottom of the housing

1. The bearing housing had worn oversize because of lacking of lubrication. The eroded area was prepared by using a Bristle Blaster
2. The worn area was rebuilt with a thin layer of Belzona 1111
3. A new housing was pressed into place and the Belzona material allowed to set up before the component was reinstalled.

The application was carried out in accordance with Belzona Know-How System Leaflet MPT-7. The damaged areas were cleaned using a bristle blaster. Then the repair areas were rebuilt with Belzona 1111. A new housing were inserted into place.
