# BELZONA REPAIRS FATTY ACIDS CONTAINMENT AREA

ID: 6322

Secondary containment area where fatty acids were stored

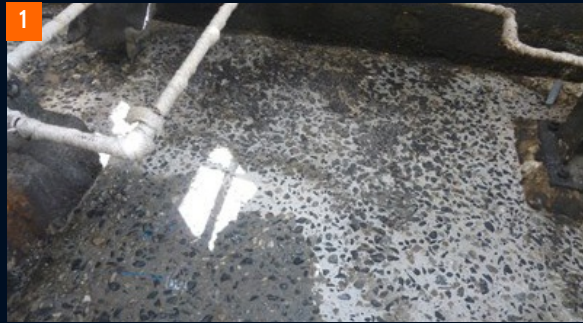
Concrete surfaces were severely corroded and eroded from leaking equipment.

1. Severely corroded and eroded concrete resulting from leaking equipment.
2. First part of the repair in contrast to the original condition. Belzona 4154 mixed with sand plus 2 coats of Belzona 5811. Draining rebuilt to eliminate ponding.
3. Closer look at the repair.

Old surfaces were pressure washed and any loose material was removed. The eroded concrete surfaces were resurfaced using Belzona 4154 mixed with sand. The surfaces were built up to original spec (up to 1.5 inches in some areas) and new gradients were created to ensure correct drainage. Belzona 4181 was used to repair the concrete directly under the steam lines. Two coats of Belzona 5811 were applied on the rebuilt surfaces. The application area was approximately 800 square feet.
