# BELZONA REPAIRS HOLES WITH BULKFILL AND MAGMA QUARTZ

ID: 6324

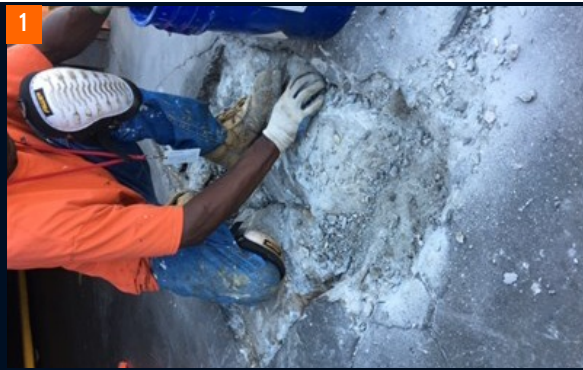
Due to continuous forklift traffic holes had formed causing an issue in operations.

1. Preparing hole by removing loose material
2. After preparation
3. Bulkfilling with Belzona 4124
4. Top coated with Belzona 4111

The holes were cleaned out and filled with Belzona 4124. Once the holes were filled, it was top coated with Belzona 4111. FPA-1 System Leaflet was followed.
