# BELZONA REBUILDS CONDUIT GAP

ID: 6325

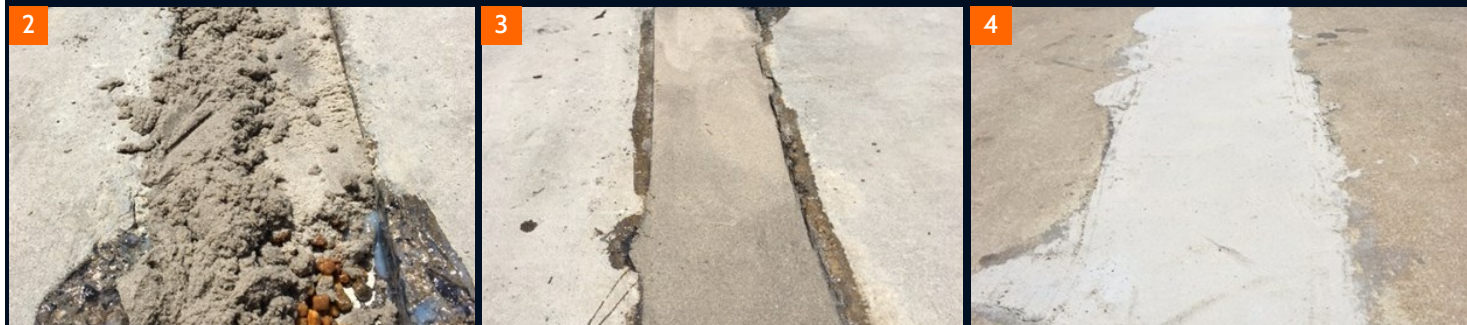
## PHOTOS

Conduit was buried in concrete. The concrete started failing.

1. Empty conduit gap.
2. Taking up volume with Belzona 4154 with river rock followed by Belzona 4154 with sand on top.
3. After spreading the Belzona 4154 with sand.
4. Top coated with Belzona 4111.

All the concrete was cleaned out and where it was not already rough, grinders were used to roughen the substrate. Belzona 4154 was mixed with clean river rock to bulkfill the conduit gap. Once the conduit gap was filled up, Belzona 4154 was mixed with sand and spread out. The bulkfill was top coated with Belzona 4111 for added strength and blend. The application was carried out in accordance with Belzona Know-How System Leaflet FPA-12.
