# GRIPPING BELZONA SOLUTION FOR THE MILLENNIUM BRIDGE

ID: 6326

Pedestrian and cyclist tilt bridge

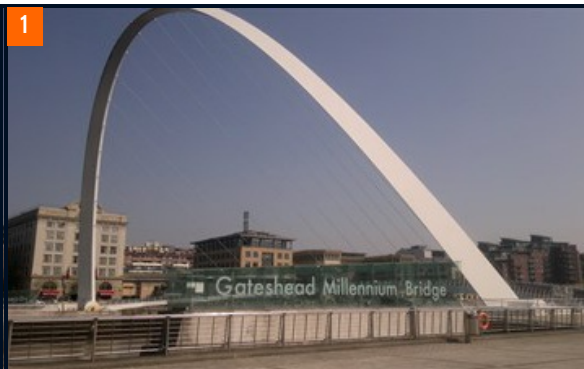
1. View of Millennium Bridge
2. Application of Belzona 5811
3. Completed patch repairs
4. Application revisited in 2016

The application was carried out in accordance with Belzona Know-How System Leaflet FPA-8. The worn areas were masked off, cleaned and dried prior to application of the Belzona system. Two coats of Belzona 5811 were applied then blinded out with Belzona 9231 Aggregate and tamped down with a piece of timber. Once the product had cured all loose aggregate was removed to reveal the desired non-slip surface.

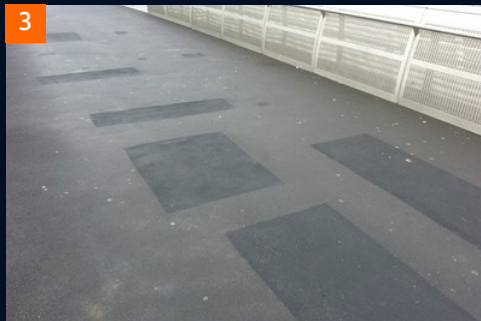
The local council required a number of patch repairs to the bridge due to wear on the original system causing slip hazards especially in the damp winter months.

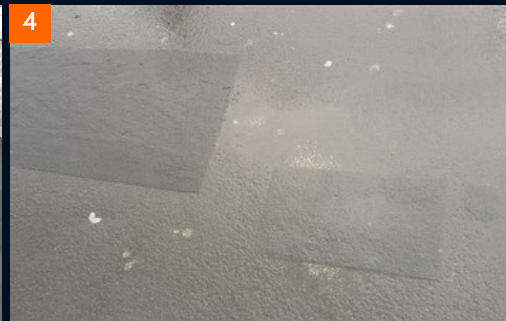
The 126 meter bridge stretches across the River Tyne and since its opening in 2001 has seen significant footfall. The Belzona repair solution, first applied in 2012 was revisited in 2016 and showed no signs of deterioration. Areas around the repair have worn away but the Belzona high performance system is still sound.
