# BELZONA SPRUCES UP STEPS AT A CONDOMINIUM AND PROTECTS FROM UV

ID: 6327

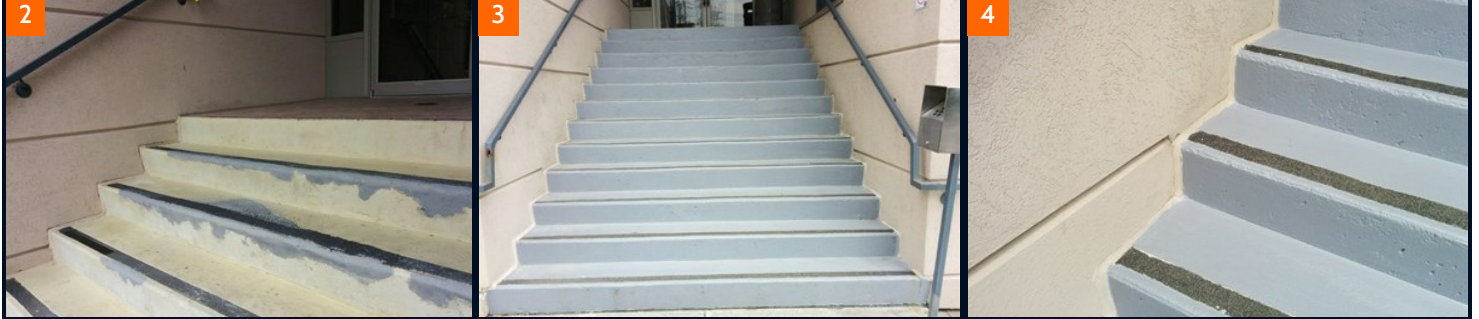
The existing coating that was applied was not UV resistant and had changed color (yellowed) due to exposure from ultra violet light. Additionally removal of ice build up with a s hovel had damaged the coating allowing corrosion of the concrete substrate.

1. Damaged steps
2. Damage repaired with Belzona 4131
3. Application of Belzona 5231 and 4411
4. Completed application of Belzona 5233 and contrasting 4411 grip system.

The application was completed by following Belzona Know How System Leaflets FPA-01 and FPA-08. Preparation of the concrete and existing coating was completed by pressure washing and removing any loose, flaking concrete and coating. The surface was abraded to ensure optimum adhesion. The localized damage was repaired using Belzona 4911 and Belzona 4131. A base coat of Belzona 5231 (with Aggregate) in light grey color was applied to all surfaces. Application of a step edge grip system was completed to current code using Belzona 4411 and Belzona 9211 to provide safety and visual contrast. A final coating of Belzona 5233 was then applied to provide aesthetically pleasing finish and UV resistance.
