# BELZONA COATS SUBMERSIBLE PUMP FOR POTABLE WATER

ID: 6328

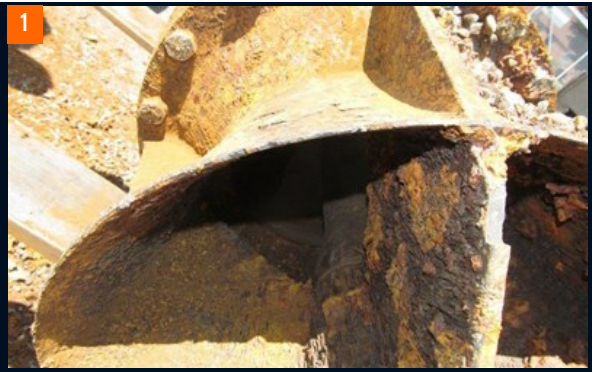
After several years in use this pump needed to be repaired and protected due to erosion/corrosion. Being a filtration plant a product with NSF 61 approval was specified by customer.

1. Corroded suction bell needed repair
2. Suction bell rebuilt with Belzona 1111 and overcoat with Belzona 5812DW
3. Other pump parts coated inside out with Belzona 5812DW

Belzona surface preparation respected. 3 mils roughness profile. Aluminium oxide angular abrasive was used for blasting. Belzona system leaflets, CEP-3, 4, 6, was followed.
