# BELZONA 7111 ALIGNS NEW INDUSTRIAL EQUIPMENT

ID: 6329

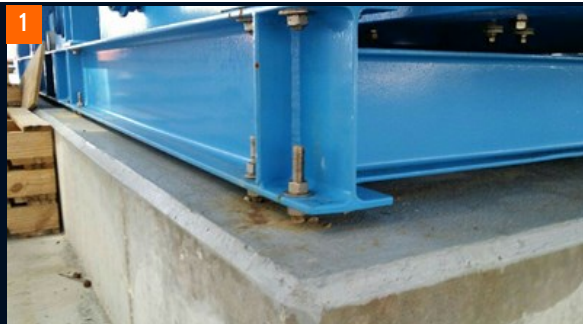
1. View of the gap needed to be filled.
2. Temporary wood dam and expansion joint.
3. Pouring of first layer.
4. After dam removal.
