# BELZONA PROTECTS LISTED BUILDING

ID: 633

Grade 1 Listed Building

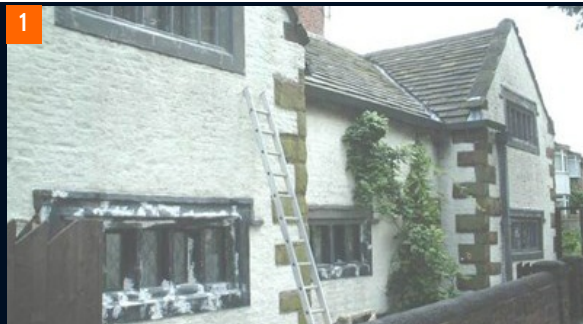
Traffic, pollution and grime had discolored the facade of the building.

1. Before application
2. During application, surface conditioned
3. Completed application

Eleven years previously this building had been coated in Belzona® 3111 to stop external water and damp ingress. After inspection it was revealed that although it had become very grimy the Belzona coating was still in very good condition and would continue to function. The client decided that rather than just cleaning it, a self cleaning coating from Belzona would be better. The building is still looking good four years later.
