# LEAKING FLANGE COUPLINGS SEALED WITH BELZONA

ID: 6331

Flange couplings at a paper press machine

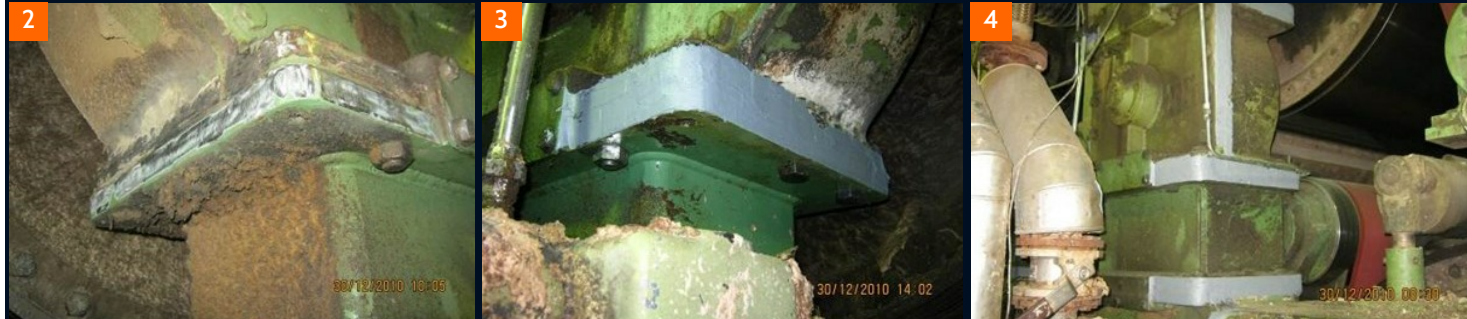
## PHOTOS

After several years in operation and due to vibration, oil started to leak from some couplings leading to pollution and loss of efficiency.

1. Leaking flange coupling 2. Surface preparation 3. Belzona repair 4. Belzona repair

The application was carried out in accordance with Belzona Know-How System Leaflet TCC-1 for sealing cracks, porous welds, bolted and riveted joints. The surface was cleaned with Acetone and abraded using the MBX bristle blaster. Belzona 1161 was applied in conjunction with Belzona 9341 to seal the leak.
