# BELZONA PROTECTS MAIN ENTRY OF APARTMENT

ID: 6332

Main entry of apartment

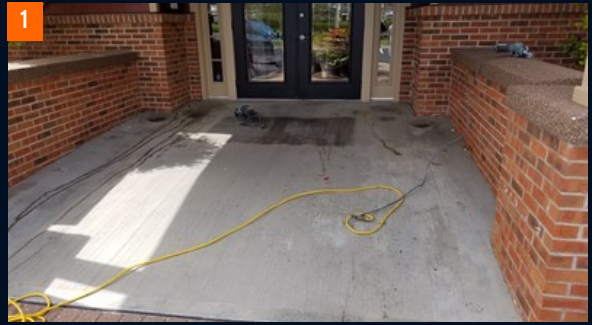
The apartment complex recently had concrete replacement on its clubhouse, including the main entry, sidewalks, and curbing. The management was worried that the new concrete would not last unless protected. There were concerns of inclement weather and subsequent ice melts and salts being used, staining from watering the plants and constant pedestrian traffic and deliveries.

1. The original appearance of the entry with the planters and floor mats removed 2. Diamond grinding under way 3. Application of Belzona 5231 4. Completed application of 5231/locally sourced aggregate/5233
