# BELZONA PROTECTS INTERNAL OF CHP STACK

ID: 6335

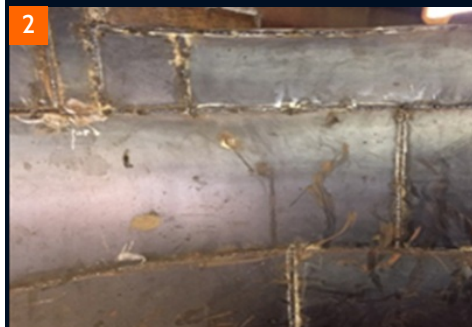
1. CHP Stack
2. Plates welded in place during previous attempted repairs
3. Base of the stack coated
4. completed Belzona 1593 coating

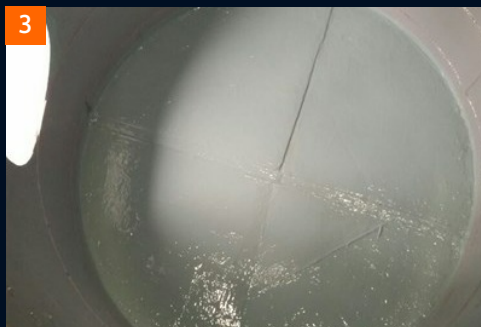
The stack had been experiencing corrosion issues from the chemicals within the flue gas stream. It was suspected that acids within this stream were condensing on the vertical wall of the stack & causing excessive corrosion around the localized area. Repairs had been attempted in the past by welding mild steel plates to the internals of the stack during shutdowns. This did not solve the problem & the base issue kept occurring year after year.
