# BELZONA REPAIRS DOME ROOF

ID: 6336

Mosque, Woking, UK

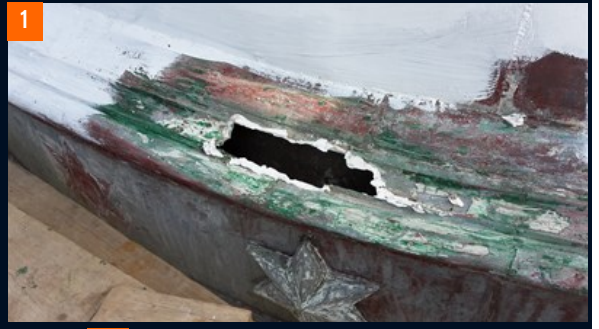
The dome was showing signs of ageing and there were a large number of holes around its circumference.

1, Extent of the damage 2, Damaged zinc dome rebuilt with Belzona 1121 3, Belzona 3111 applied 4, Completed application prior to the removal of the scaffolding
