# BELZONA PROTECTS HAZARDS DRAIN TANK

ID: 6337

A hazards drains tank found to be suffering metal loss when UT inspected.

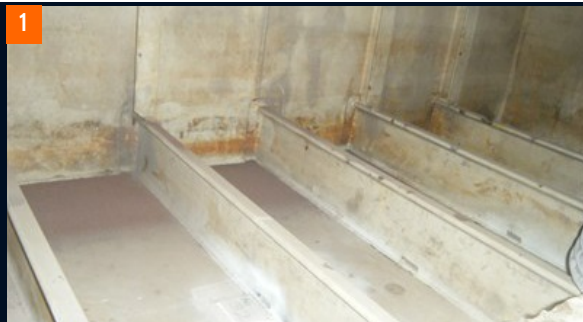
Once opened and inspected it was decided to replace the lower 1 meter of the existing coating before putting the tank back into service. MIC (microbiologically induced corrosion) was affecting the bottom of the tank and causing local pitting of the steel.

1. Original coating 2. Grit blasting underway 3. Inspection of 1st Coat 4. Completed application with 2nd coat applied.
