# QUARRY BELT REPAIR

ID: 634

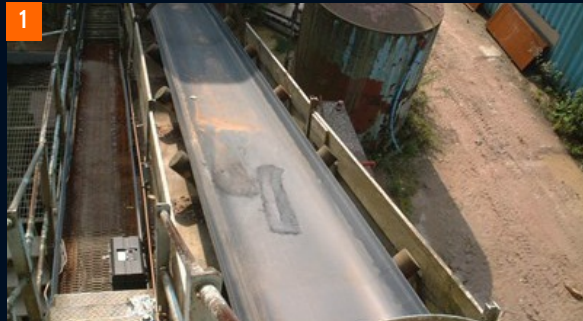
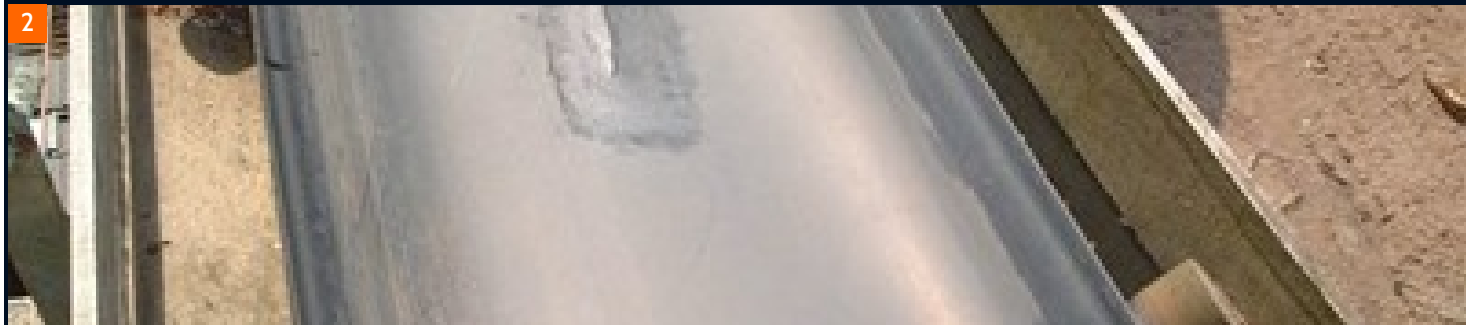
600mm (23inch) tear in the belt

Large sand belt 600mm gash in the belt

Application was carried out in accordance with Belzona Know-How System Leaflet SHM-1.

Belzona® 2311 (SR Elastomer)
