# BELZONA REPAIR ON CONCRETE DAM

ID: 6343

The face of the 100 yr old concrete hydro dam was damaged at the waterline due to ice and wave action.

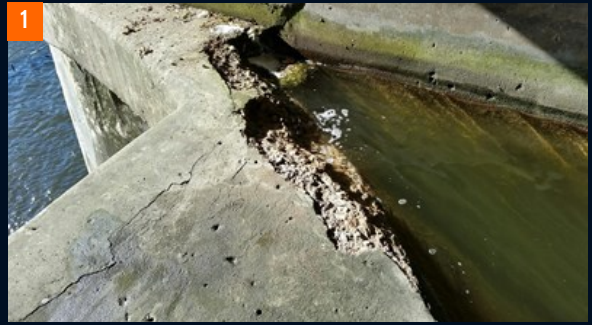
The damaged area is partially submerged and the entire area frequently wet from wave action. The dam has been declared a historic site so repair materials need to closely match the appearance of the original material.

1. Damaged area at waterline
2. Work in process.
3. Finished repair

A temporary dyke was created around the area needing repair. Compressed air was used to blow the standing water off the damaged area. The surface was prepped with chisels and a bristle blaster. Dust and loose debris were blown off. The 4911 was applied and the repair was made with 4141 to just below the desired finish level. Finally a coat of 4131 was applied to finish the work.
