# BELZONA REPAIRS AND COATS END SUCTION PUMP CASING

ID: 6344

Centrifugal Pump at a papermill.

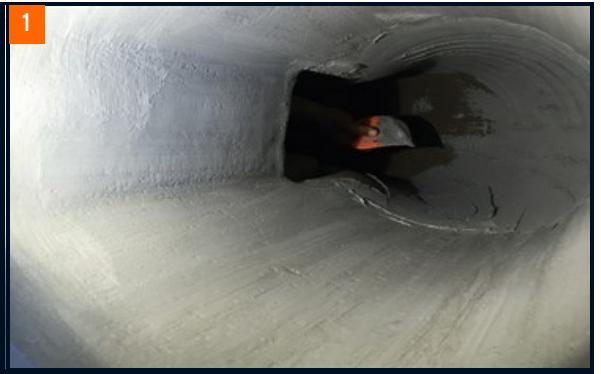
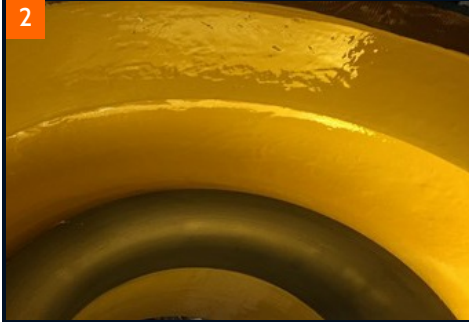
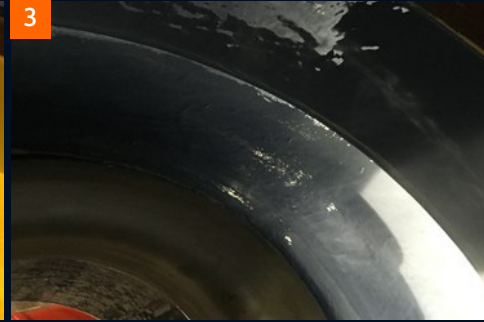
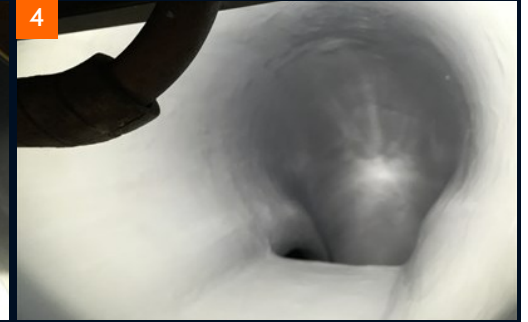
The casing was badly damaged and cracked

1. Installing Belzona 1121 to fill pits and form smooth uniform surface 2. First coat of Belzona 5821 applied at 10 mils 3. Second coat of Belzona 5821 being applied at 10 mils 4. Two coats of Belzona 5821, total DFT of 20 mils

Surface was abrasive blast to a cleanliness standard of SSPC-SP10 and a minimum of a 3 mil angular profile on internal wet area. Internal pitting and repair damage was filled with Belzona 1121. Two (2) coats of Belzona 5821 was applied at a minimum of 10 mils per coat on internal surfaces. Coated components were inspected and any holidays or imperfection was corrected. Application carried in accordance to system leaflets CEP-3 and CEP-5.
