# BELZONA STRENGTHENS REFUGE ON OFFSHORE PLATFORM

ID: 6346

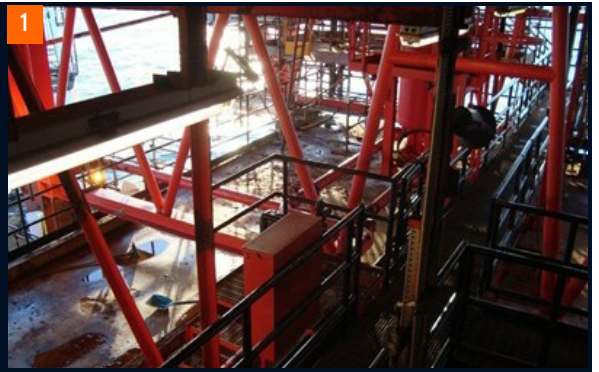
Severe corrosion had caused pitting with some penetrations through the roof reducing the integrity of the refuge. The refuge had to withstand a blast load of 0.25 bar. As this is an active gas storage unit, welding was not an option for repairs.

1. General view of the roof 2. Positioning doubler plate onto Belzona 4111 3. Plates bonded where access was restricted 4. Completed application

Application was carried out in accordance with a modified Belzona Know-How System GSS-9. A slurry mix of Belzona 4111 was used to bed steel doubler plates to cover the roof of the refuge. Penetrations through the roof were initially sealed with small plates bonded in place with Belzona 1211. A fire protection coating was finally applied to provide the required fire rating.
